SWITCH POINT INSPECTION & WHEEL-CLIMB DERAILMENT PREVENTION

FRA Track Safety Symposium
St. Louis, MO
April 5 – 7, 2022

Brad Kerchof
Advanced Rail Management
Norfolk Southern Railway (retired)

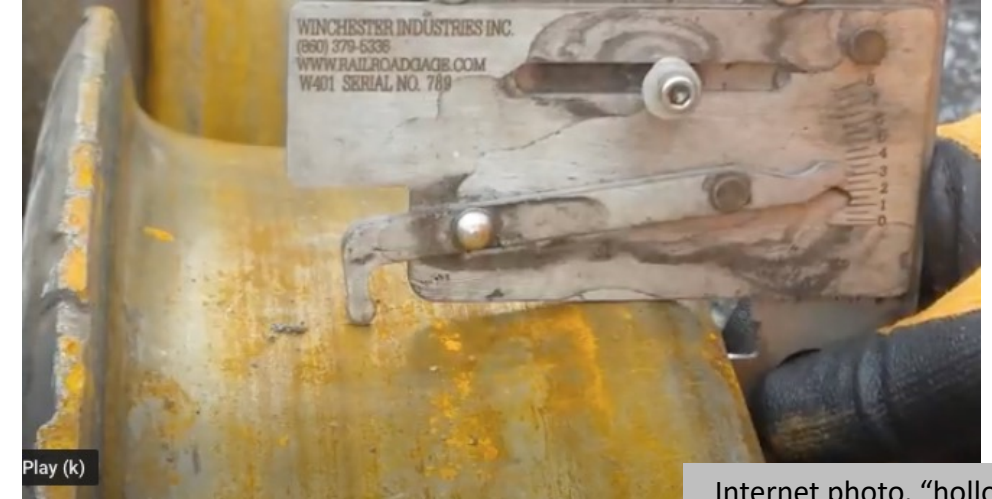
Internet photo, "hollow tread wheel gage"

Gages that determine compliance with wear standards!

Common wheel wear defects:

- ~~Thin tread~~
- ~~Hollow worn tread~~
- ~~Thin flange~~
- ~~High flange~~
- Vertical flange

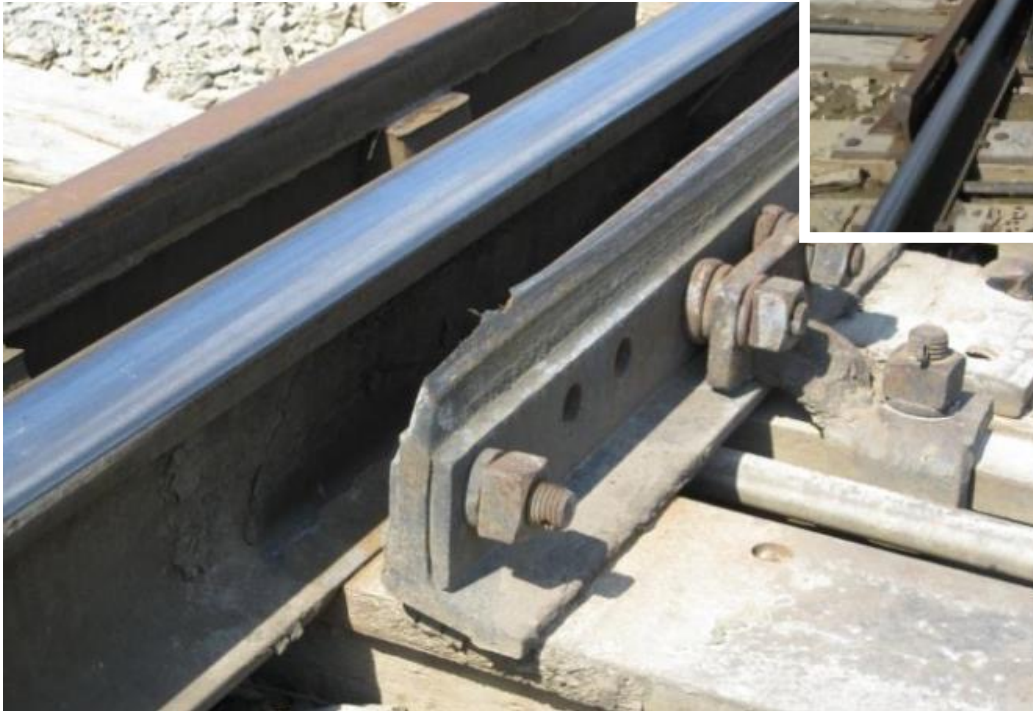
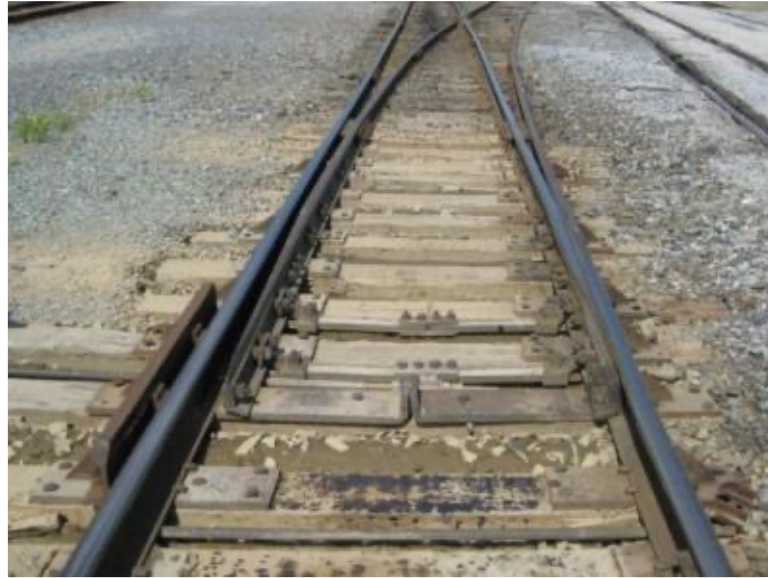
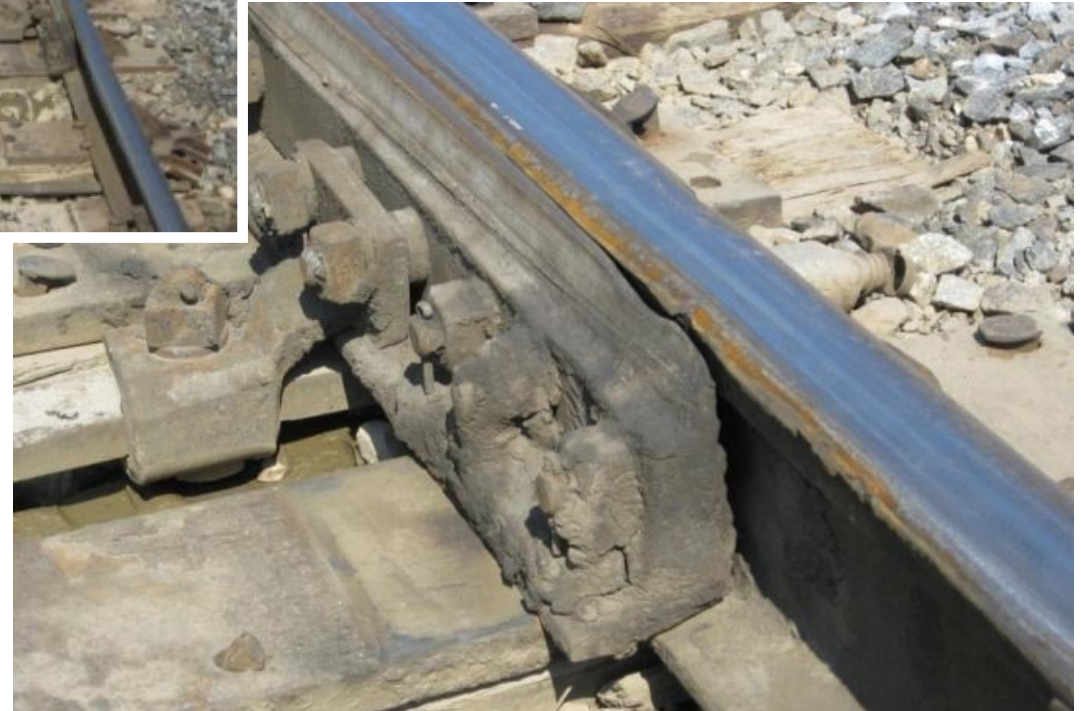
WHICH SWITCH POINT IS OF GREATER CONCERN?

From an FRA Track Safety Standards perspective?

From a derailment risk perspective?

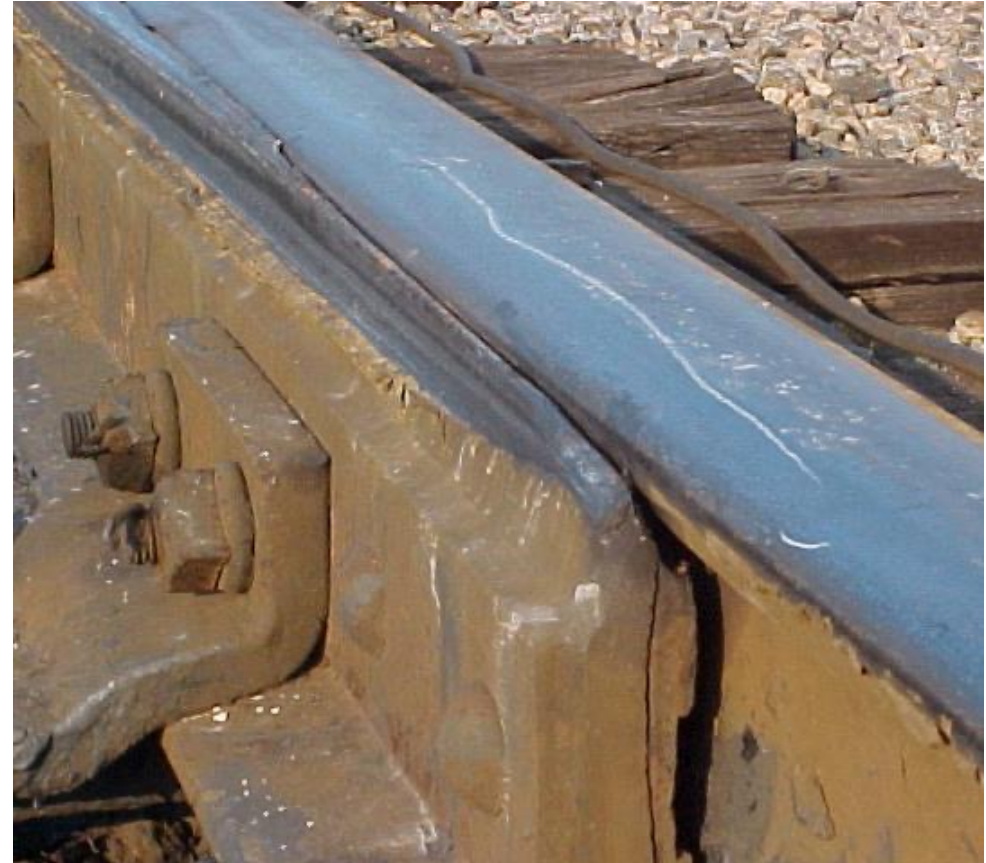
1. A gapped, worn or broken switch point

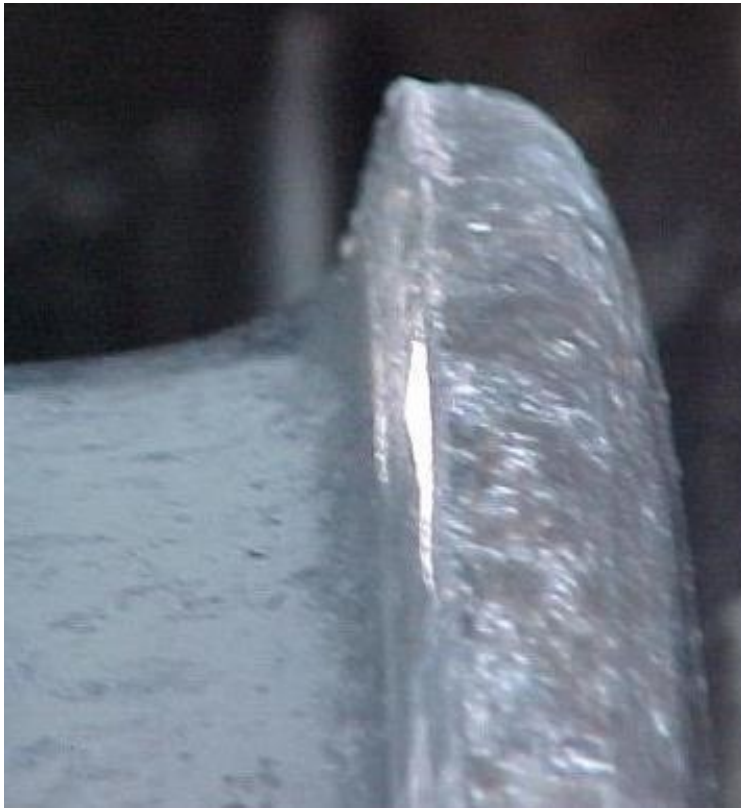
WHY DOES A WORN WHEEL INCREASE RISK OF WHEEL CLIMB?

A worn flange root allows the flange tip to get much closer to the point

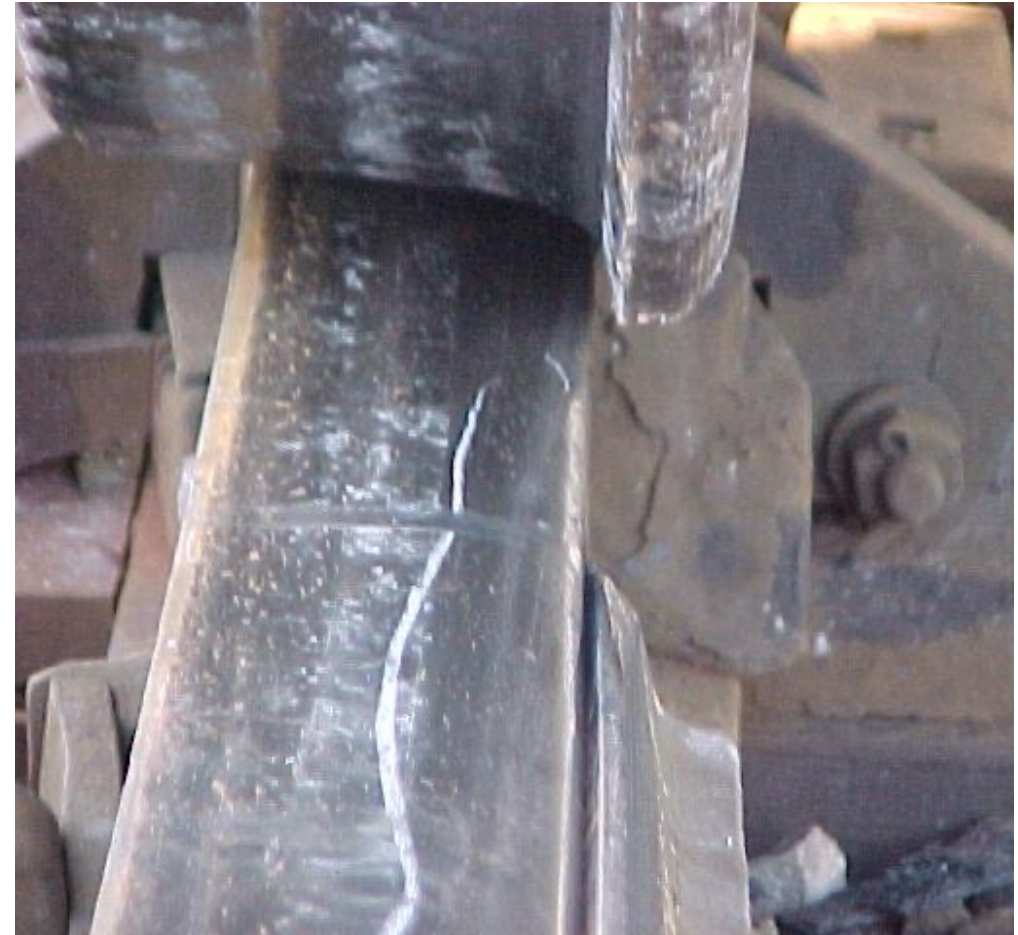
1. A gapped, worn or broken switch point
2. A worn wheel
3. Tracking position – the worn wheel is shifted toward the switch point

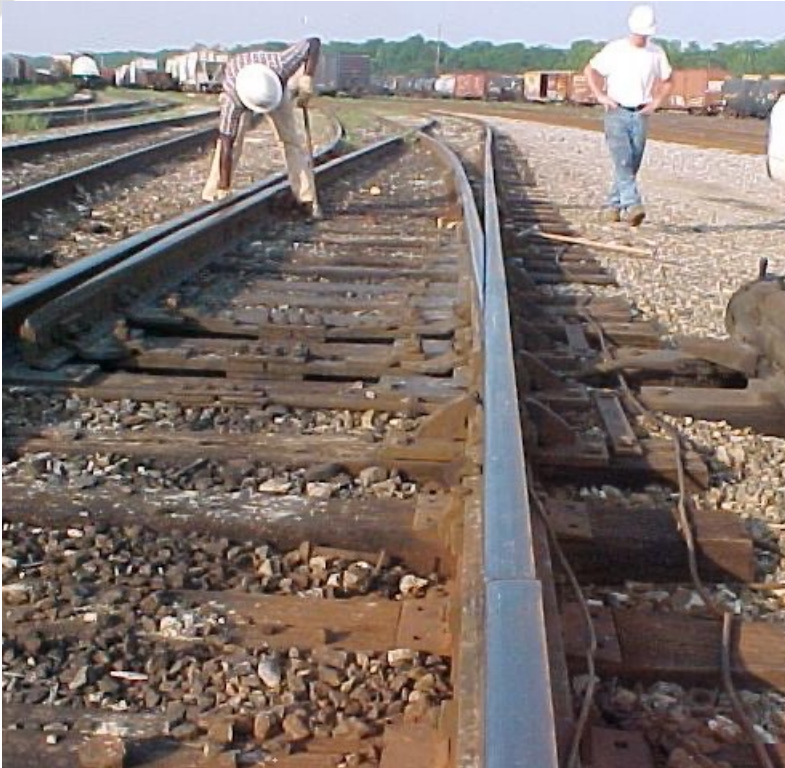
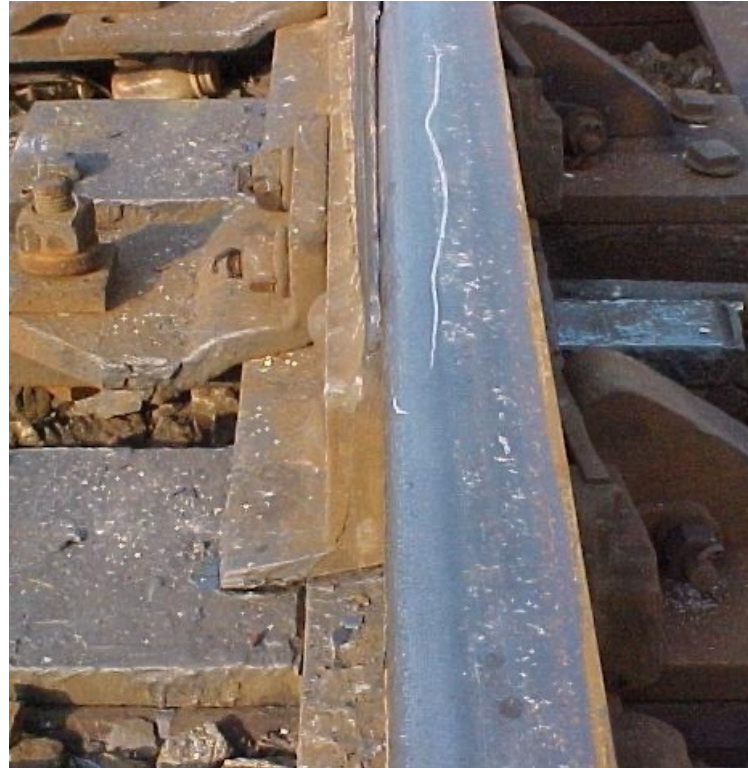
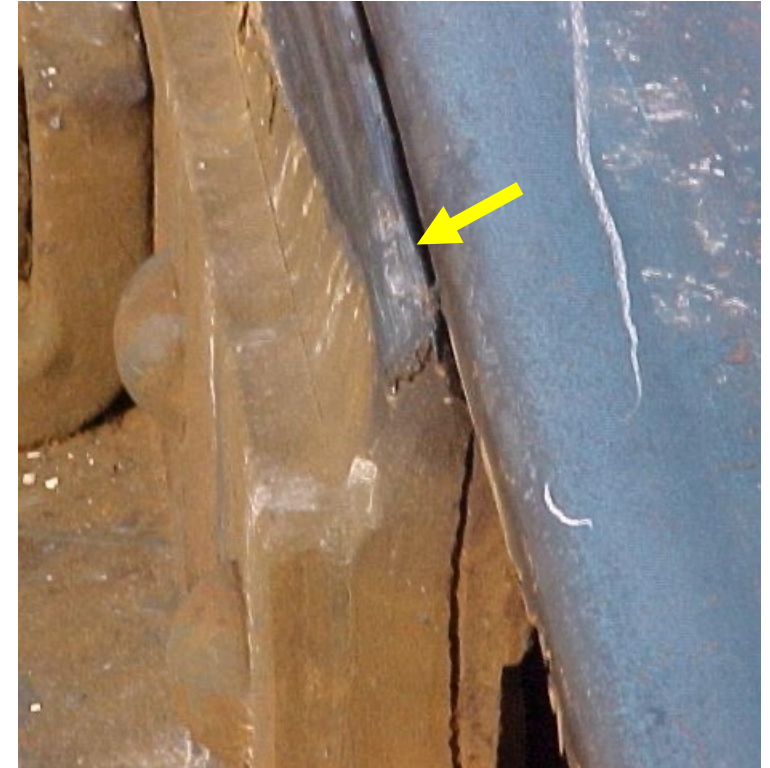
DID A WHEEL CLIMB THIS SWITCH POINT?

Three things to note about this switch point:

- 1) Slight gap
- 2) Wheel flange contact near the tip
- 3) Wheel flange mark on top of the point

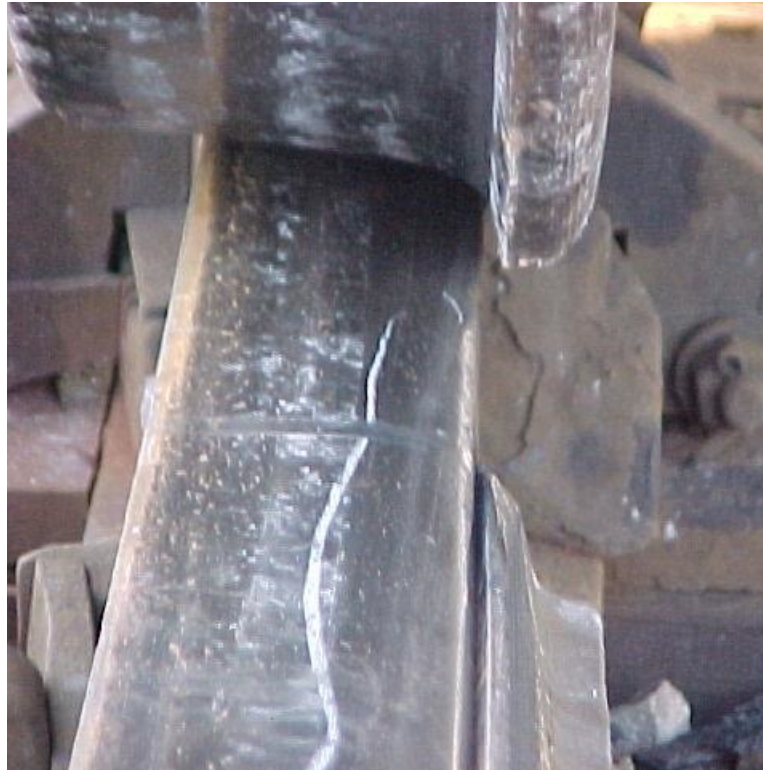
The worn flange is tracking close to the stock rail

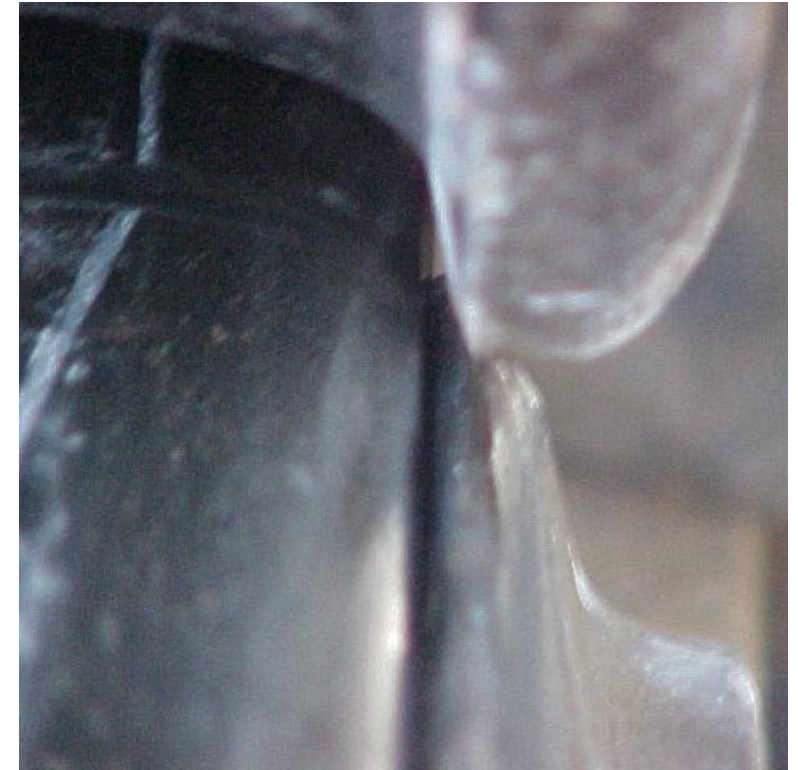
We have wheel climb!

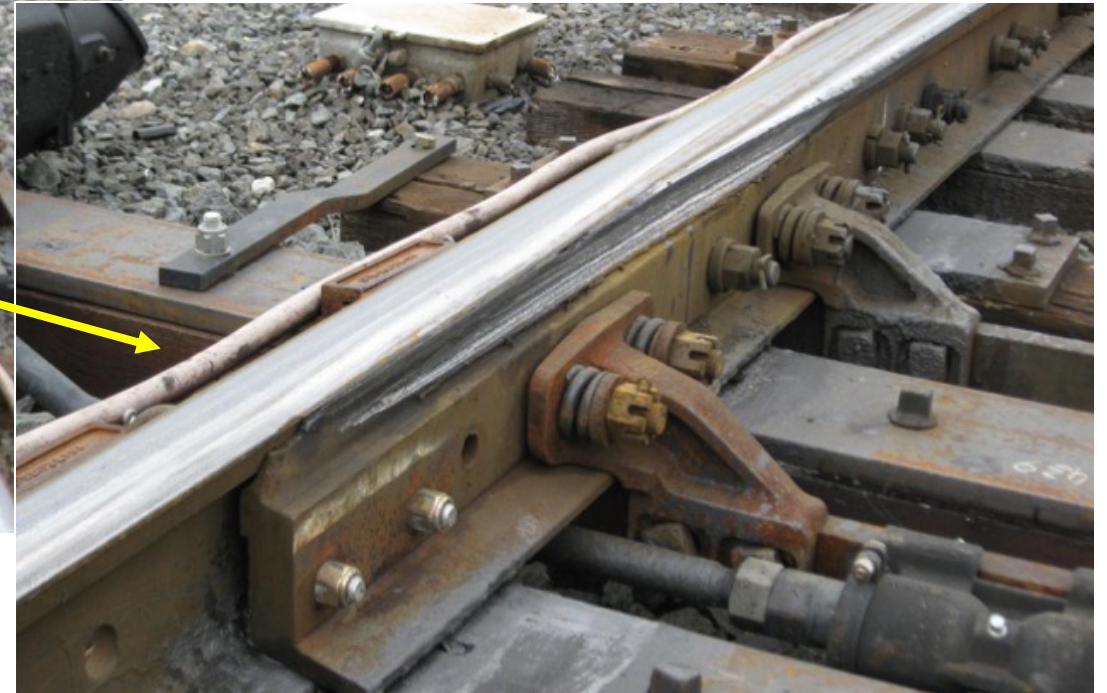
WHAT'S WRONG WITH THIS PICTURE?

The protector is on the wrong side - it is protecting the straight point instead of the diverging point

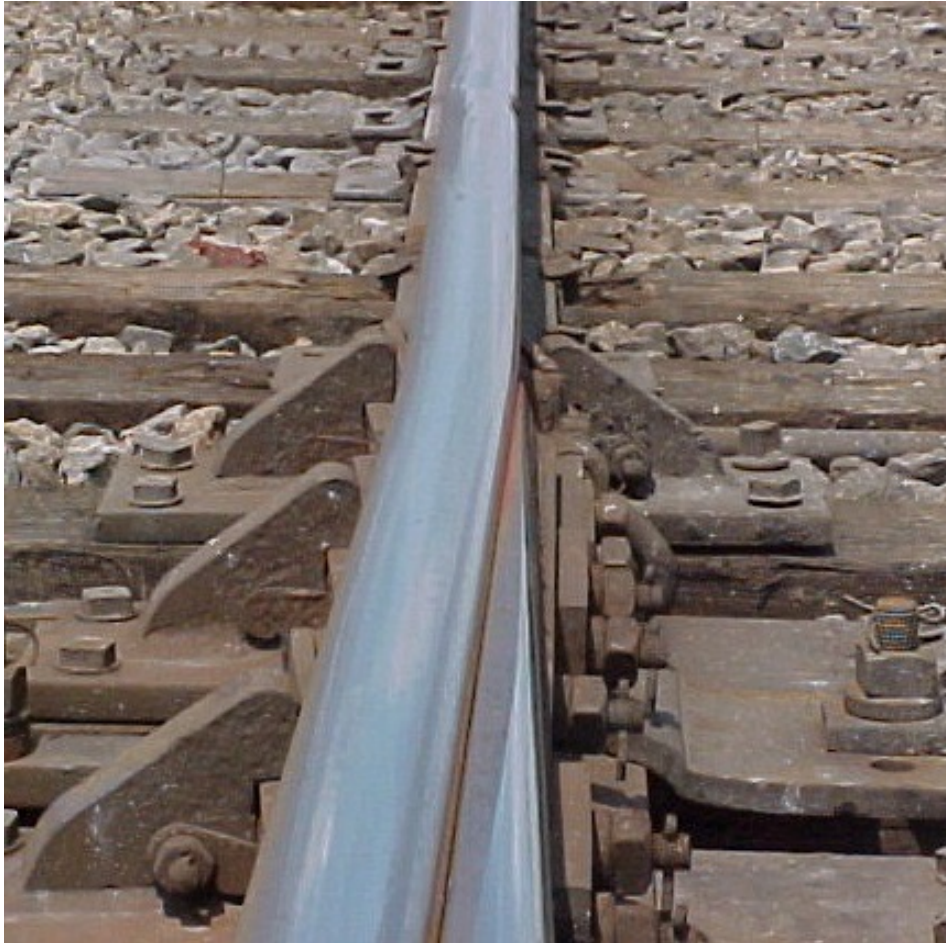
WHAT'S WRONG WITH THIS PICTURE?

You are looking at a bent stock rail and a straight point

Hint: This is a welded switch point with floating heel block (no bolts connecting point to stock rail).

A: The point was installed too far ahead – the tip of the point is at the stock rail bend!

The point is not protected behind the stock rail bend.

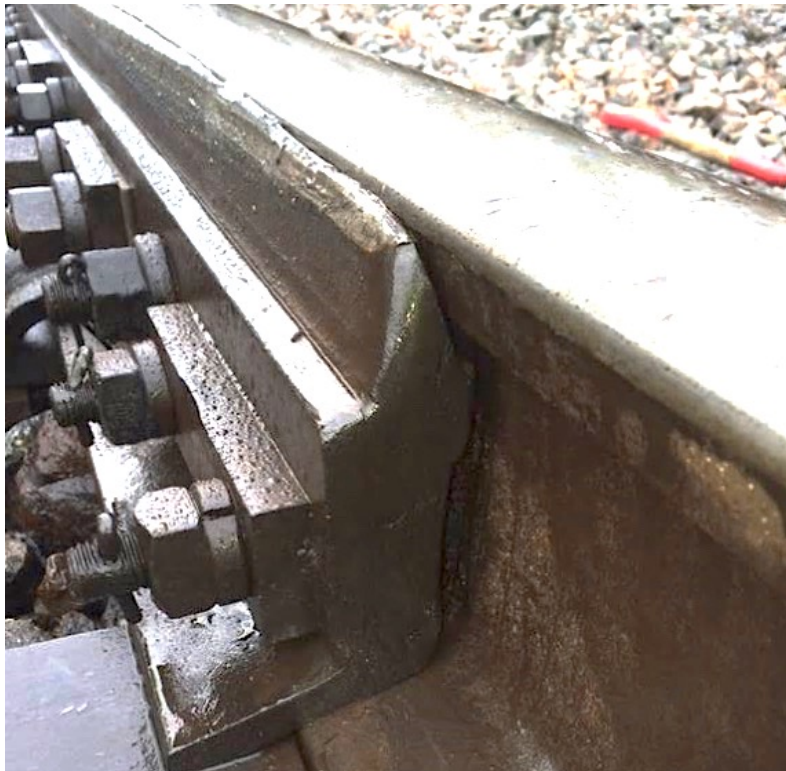
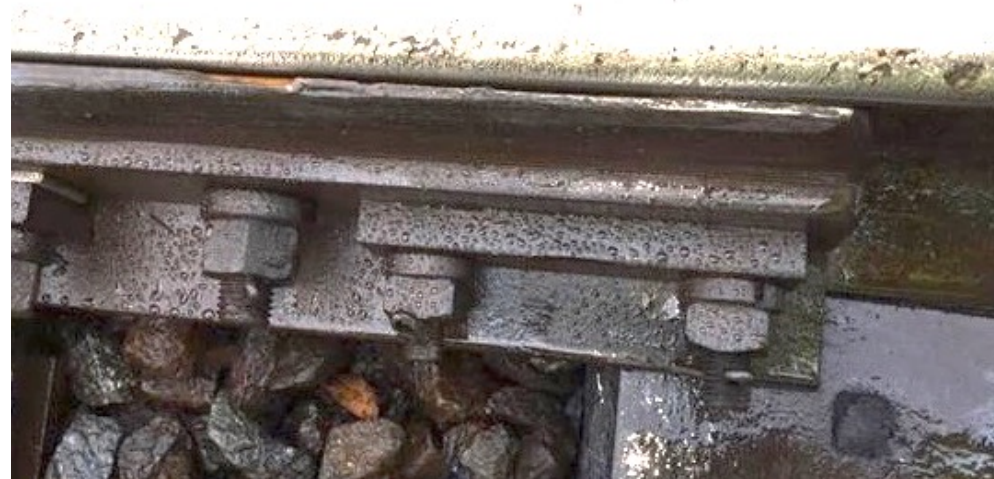
TOP-WORN STOCK RAIL INCREASES RISK OF WHEEL CLIMB

This straight stock rail has both top wear and gage-side wear, which combine to expose an unworn switch point.

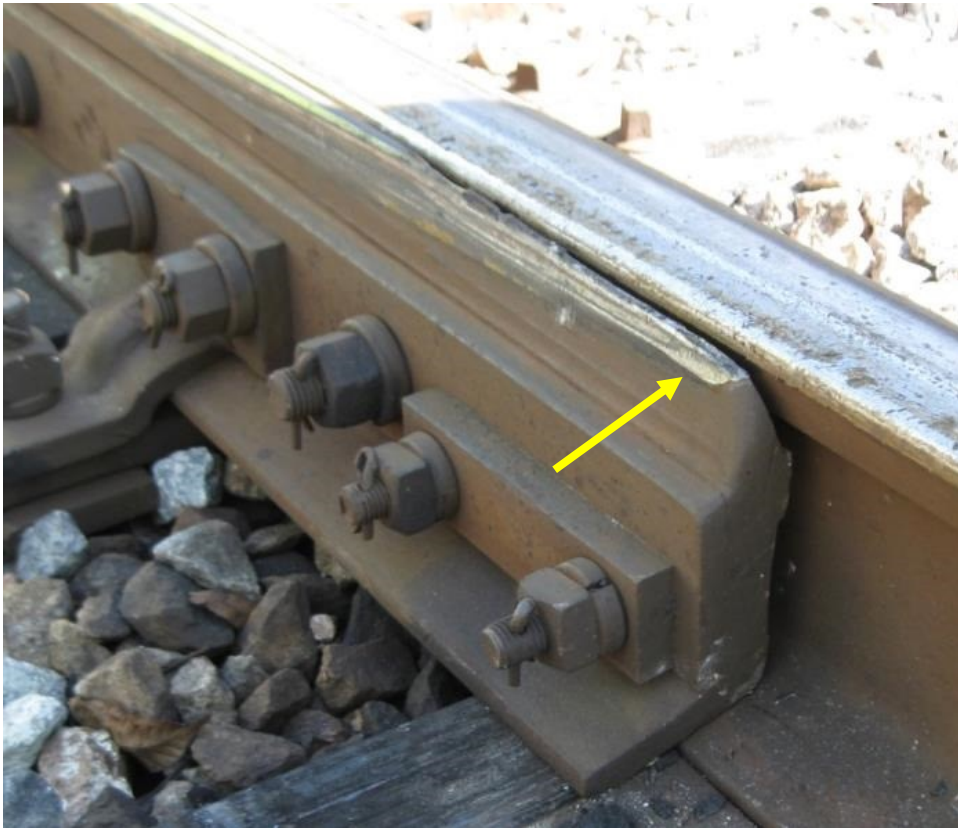
AN INDICATION THAT A PROBLEM IS DEVELOPING

Both points show evidence of wheel flange contact at the tip

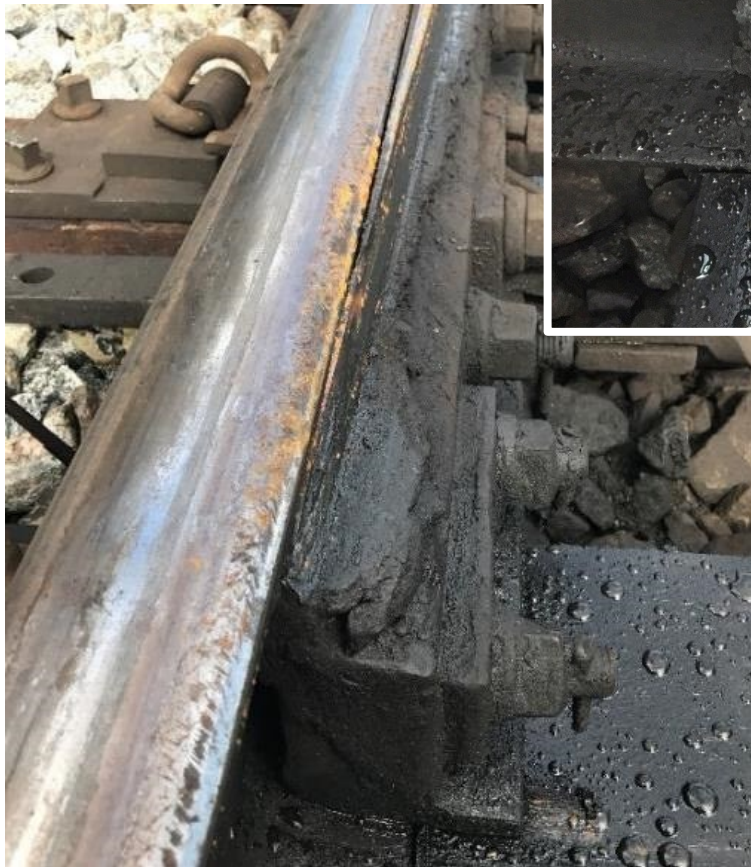
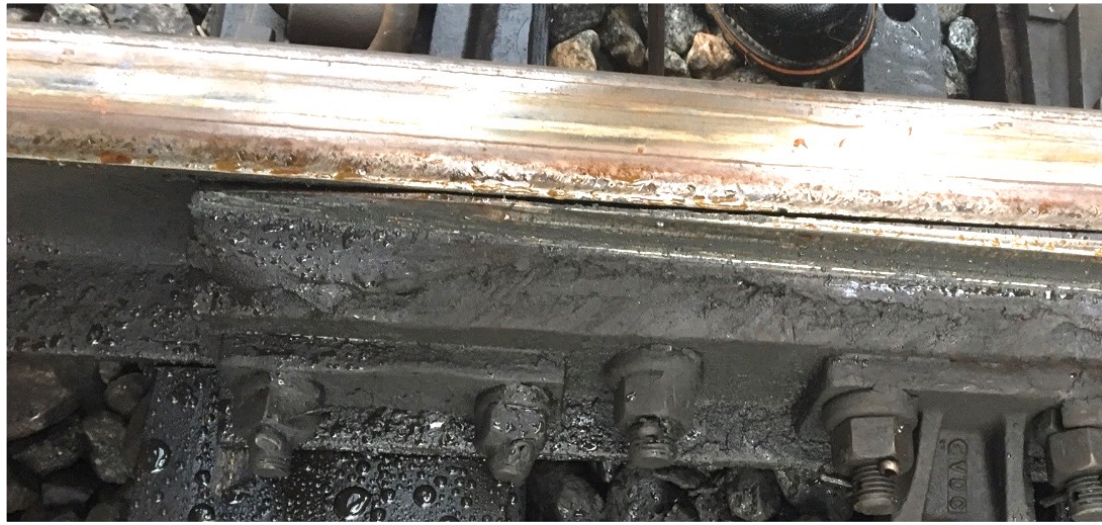
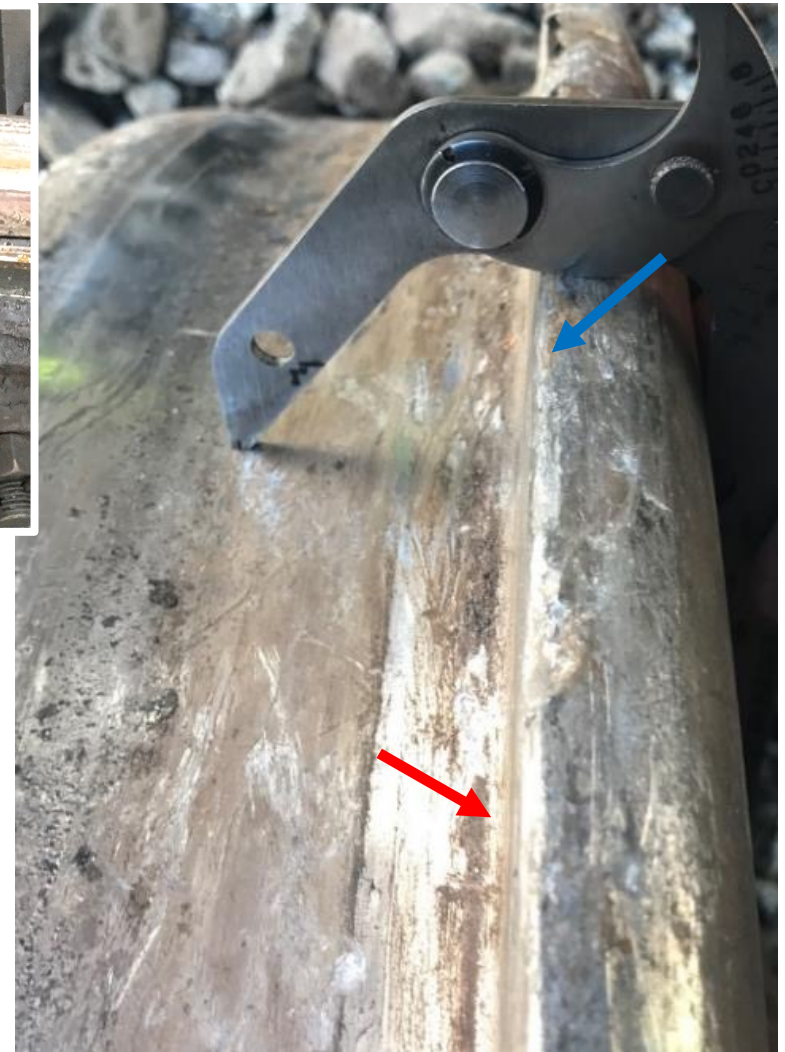
ANOTHER SWITCH POINT WHEEL CLIMB DERAILMENT

- ✓ Point moderately worn
- ✓ Tracking position - evidence of flange contact at the tip of point
- ✓ Wheel flange worn but not condemnable

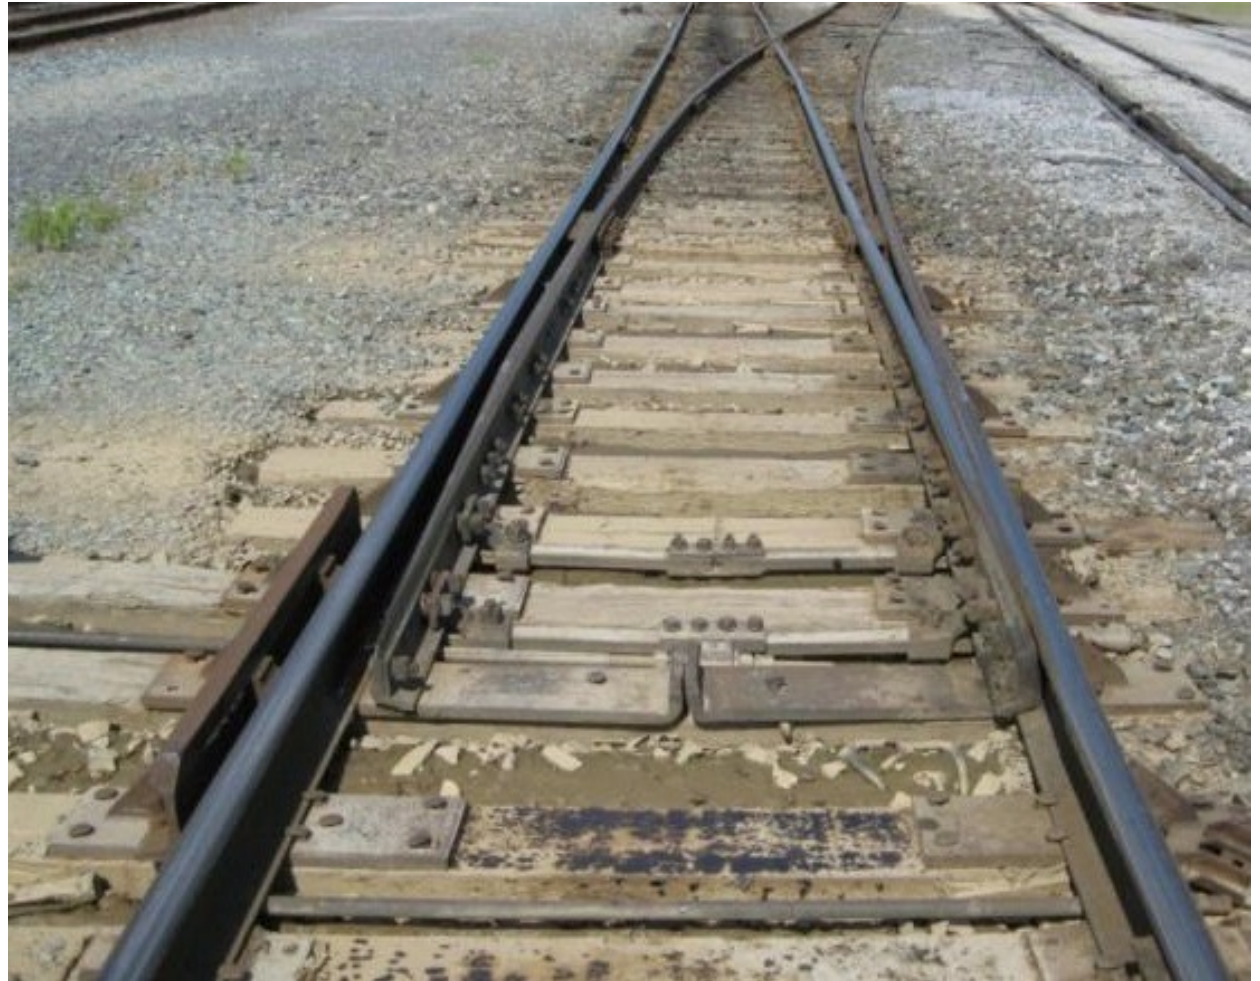
ANY CONCERNS WITH THIS SWITCH POINT SECTION?

A consequence of poor track surface:
Wheel loading can push the heel down
which can cause the front of the point to lift
up (relative to the stock rail), increasing the
risk of wheel climb.

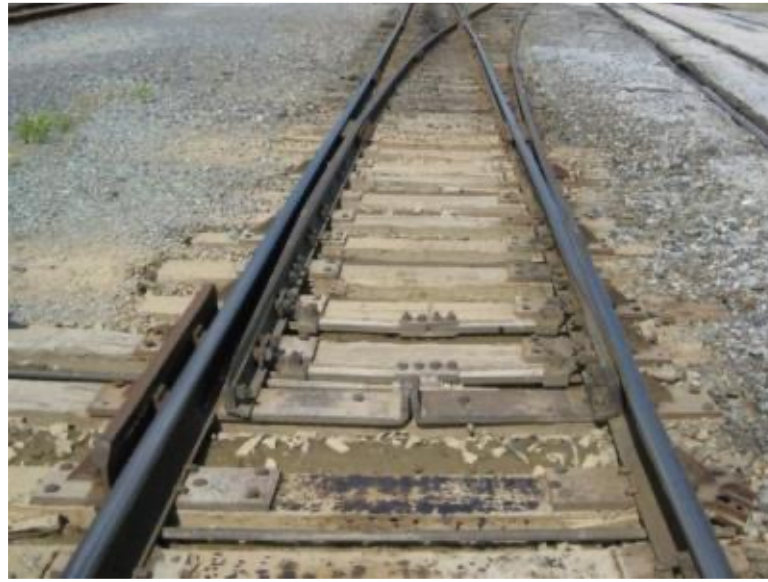
Reason for worry: Point shows wheel flange contact and a side wear.

Mitigating factor: the point protector.

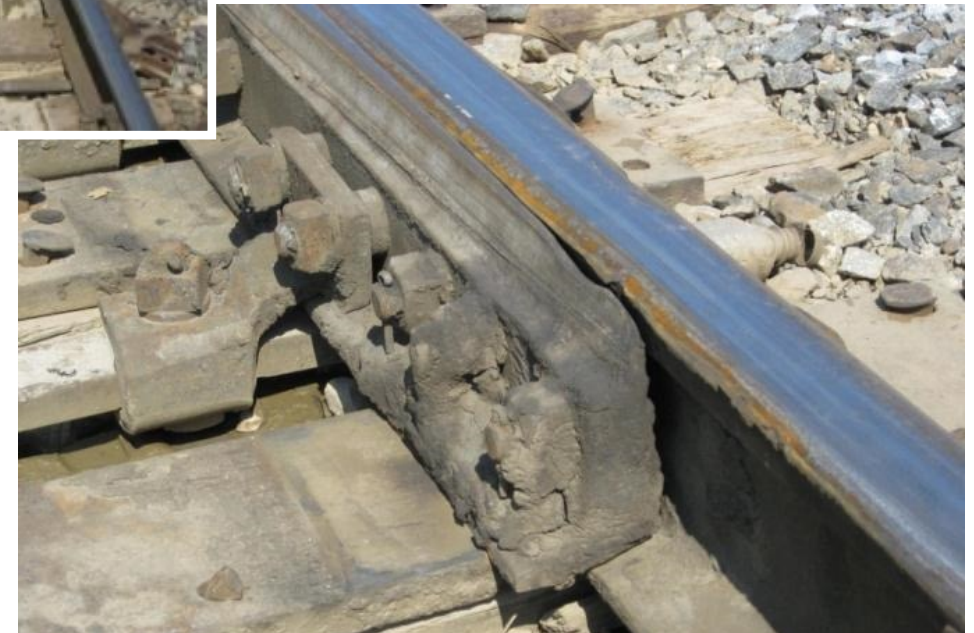
Despite stock rail lip and broken point, this point has little risk of causing a derailment – wheels are not tracking close by.

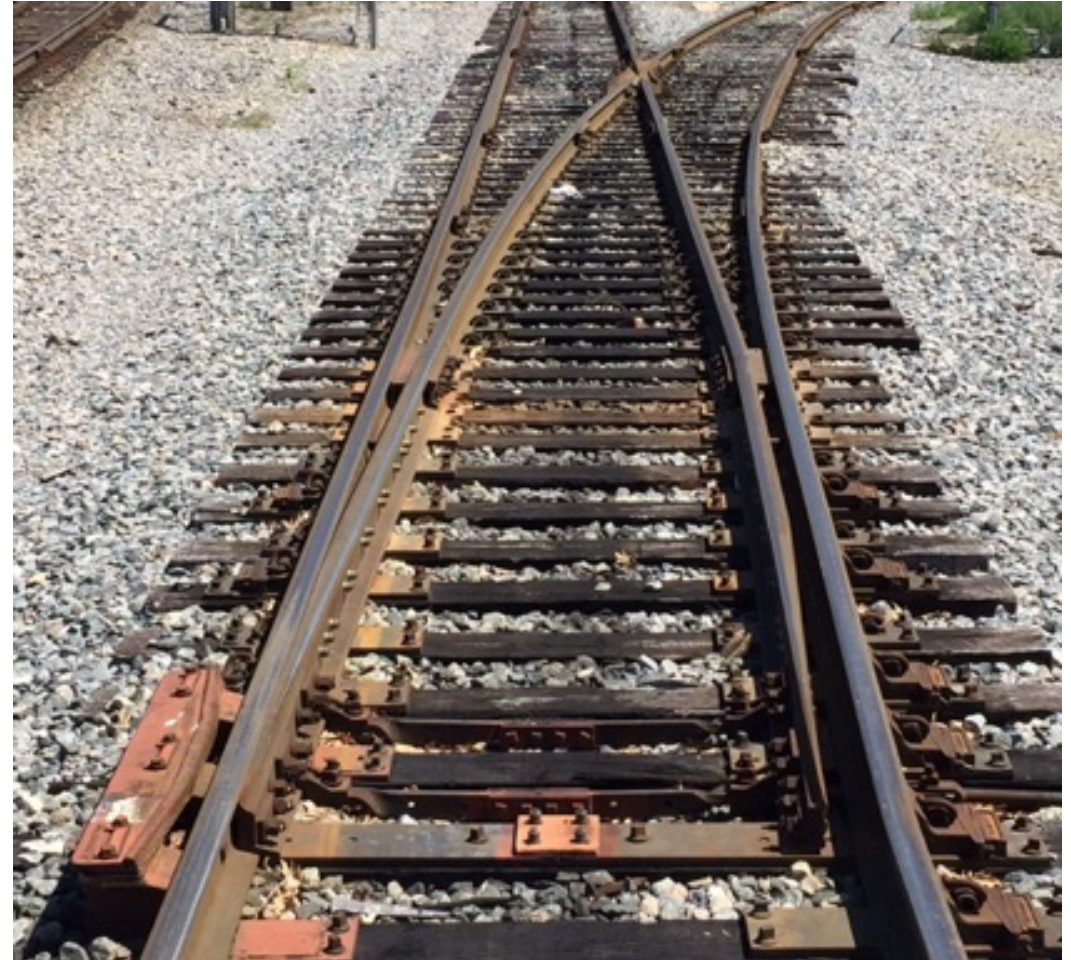
SWITCH POINT INSPECTION TIP #1

1. Operate switch to both sides to observe how the switch point fits up against the stock rail

1. Operate switch to both sides to observe how the switch point fits up against the stock rail.
2. Look for wheel flange contact at the front of the point.
3. Grind stock rail overflow.
4. Maintain your switch points with worn wheel flanges in mind.
5. Keep “tension” on your switch stand to hold the point tight against its stock rail.

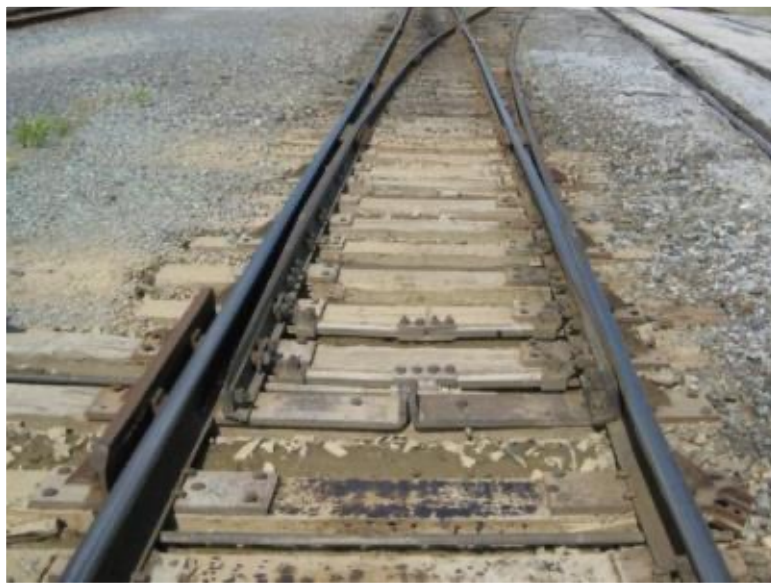
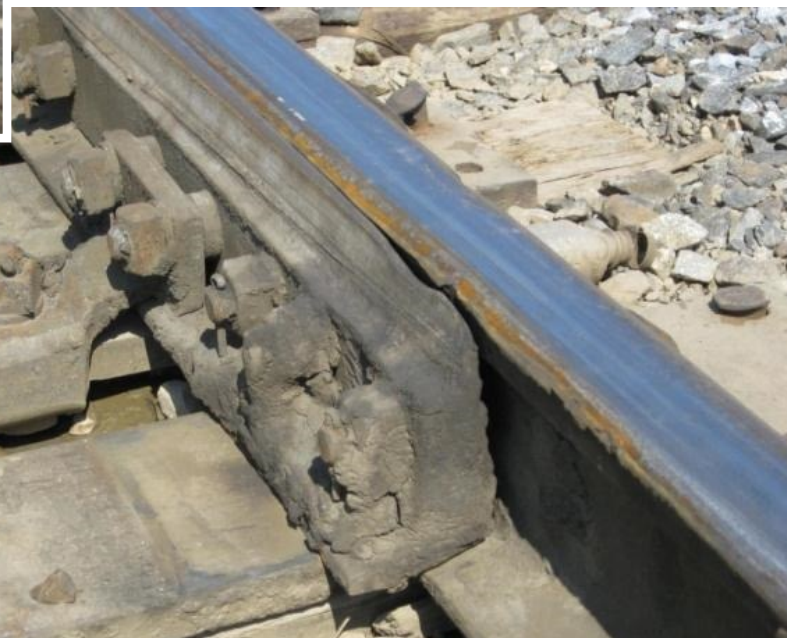
3. Grind stock rail overflow

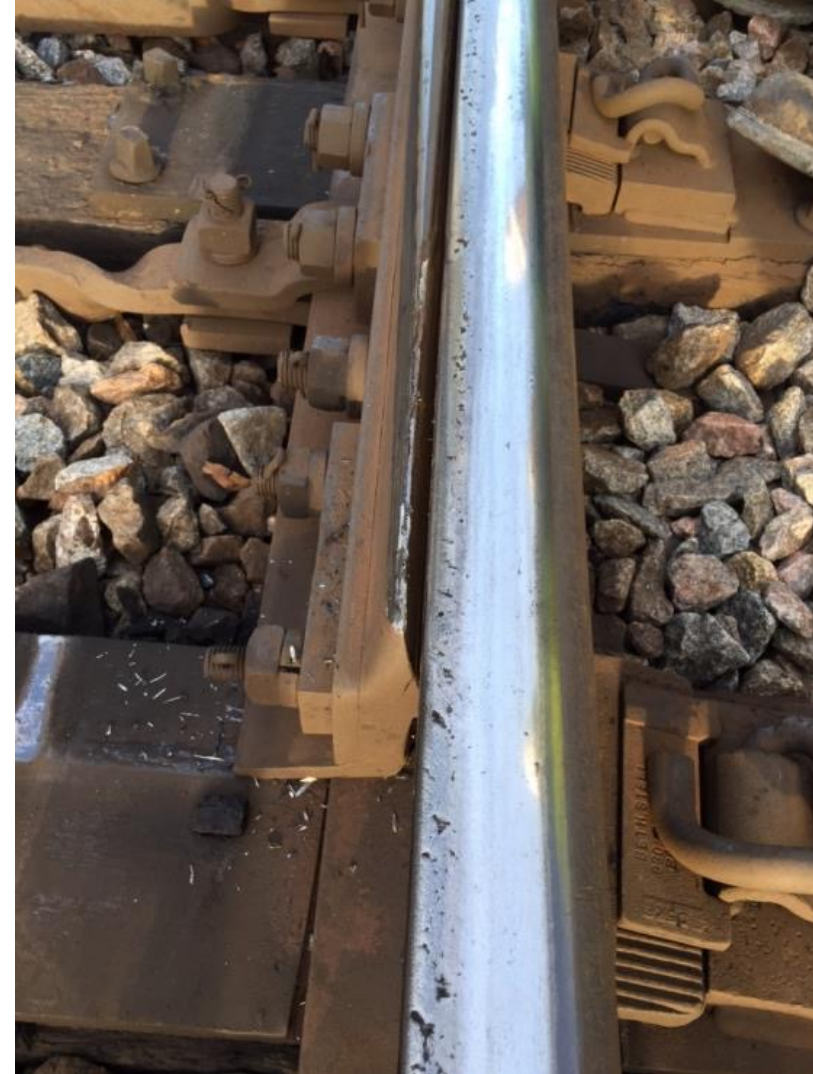
SWITCH POINT INSPECTION TIP #4

4. Maintain your switch points with worn wheel flanges in mind!

- Worn flanges are more likely to pick a poor-fitting point
- Worn flanges are common
- Most wheels that climb points are not condemnable
- A good point will accommodate a worn wheel flange

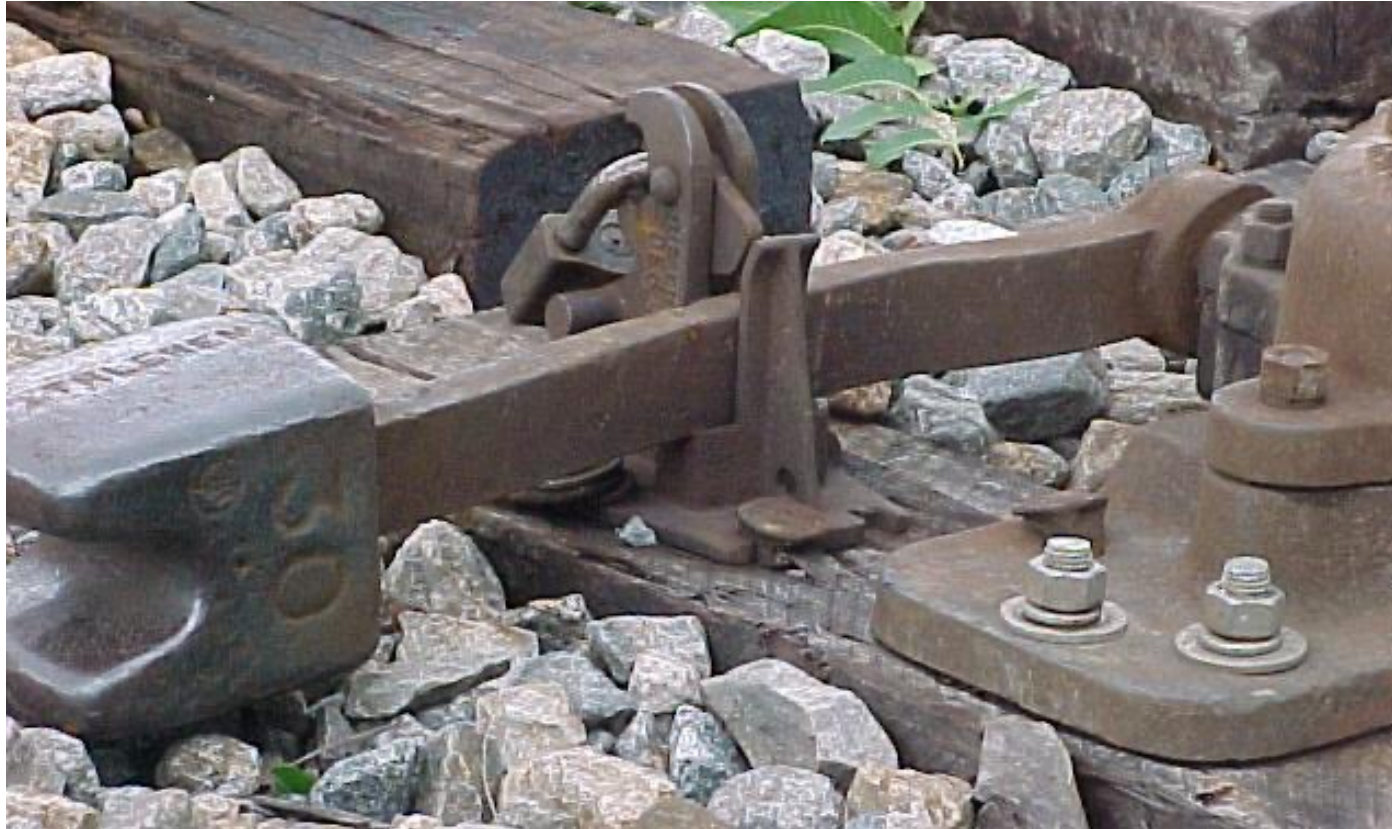
SWITCH POINT INSPECTION TIP #5

What's wrong with this switch stand?

5. Keep “tension” on your switch stand to hold the point tight against its stock rail
